**FLOODS IN EASTERN LAJAS VALLEY AND THE LOWER RIO LOCO BASIN, SOUTHWESTERN PUERTO RICO**

This report provides factual and interpretive information pertaining to floods in eastern Lajas Valley and the lower Rio Loco basin. This information provides a technical basis on which individuals, organizations and governmental agencies can make decisions leading to development on the flood plains compatible with the degree of flood risk.

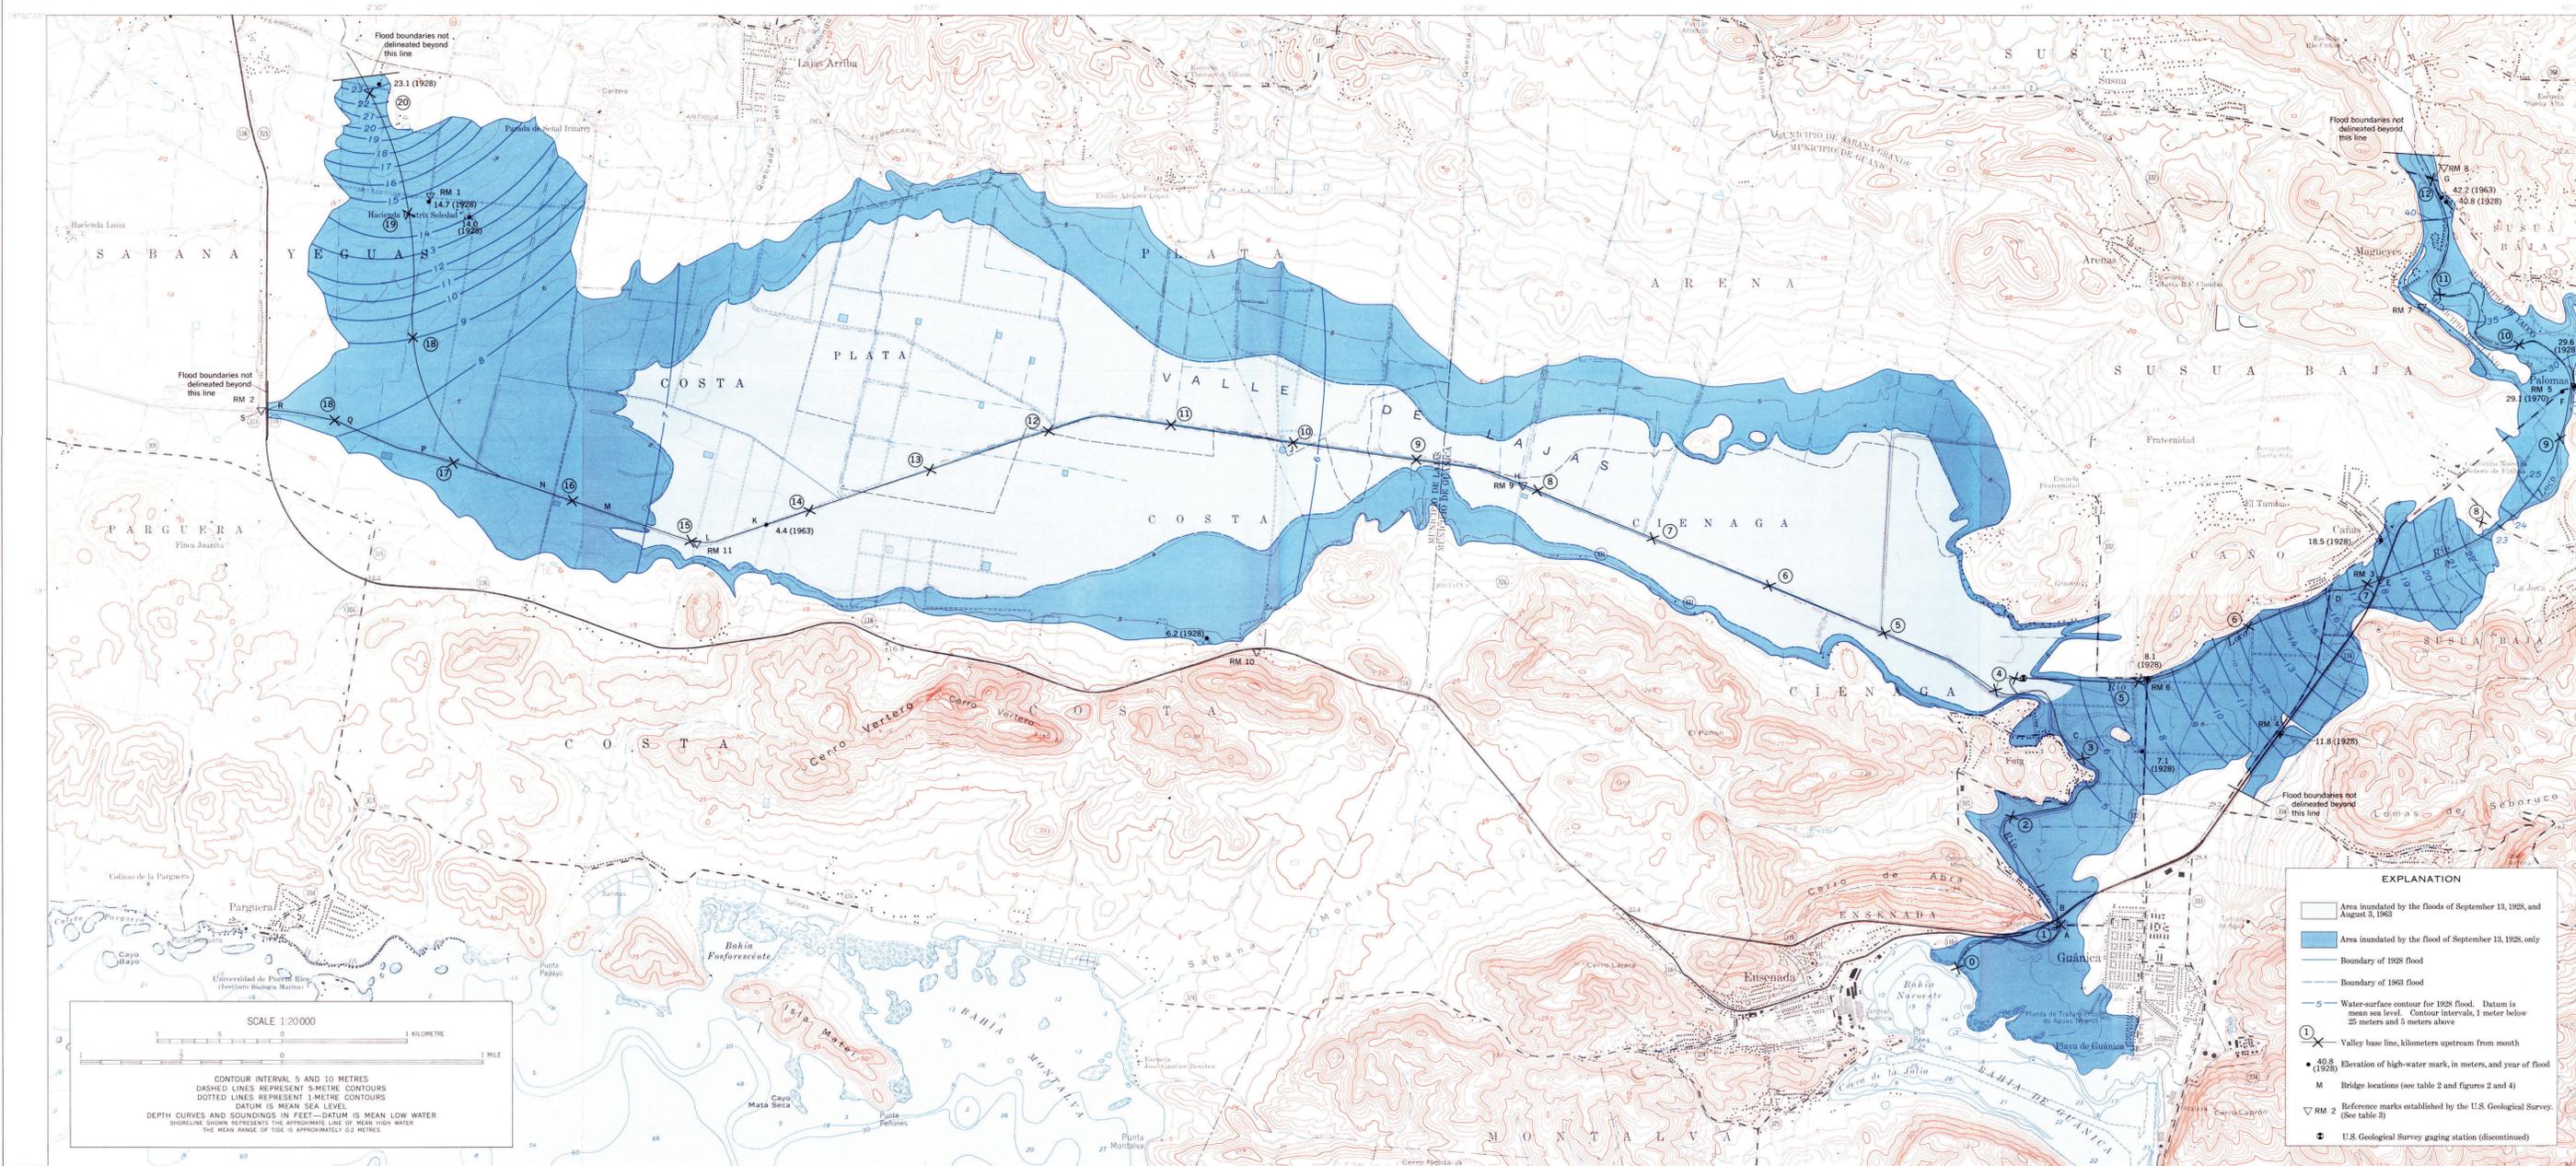
**Inundated areas.**—The areas inundated by the floods of September 13, 1928, and August 3, 1963, in eastern Lajas Valley are shown on the flood map; Rio Loco and Quebrada Maney overflowed their banks only in 1928. The flood boundaries were delineated by plotting flood-profile elevations on the map and interpolating between the contours. The flood boundaries shown reflect channel conditions during the flood. The inundation pattern of future floods may be affected by changes in channel conditions, alterations of waterway openings at right angles, changes in runoff characteristics caused by increased urbanization, and other cultural developments.

**Water-surface contours.**—Water-surface contours based on floodmark elevations are imaginary lines representing equal elevations of water surface. Generally they are at right angles to the direction of flow. Obstructions to flow, either natural or manmade, and variations in valley width cause irregularities in the contours. The water-surface contours for the flood of September 13, 1928, are shown on the map.

Lajas Valley is divided into two drainage basins along a north-south line that roughly coincides with P.R. Highway 116 (flood map). The western basin has a drainage area of about 23 square miles and the eastern basin (part of the study area) has a drainage area of about 57 square miles. Before 1955 all flow from the western basin emptied into Laguna Cartagena and all flow from the eastern basin emptied into Laguna de Guánica and Ciénega El Anegado. In 1955 an extensive irrigation and drainage system was put into operation by the Puerto Rico Water Resources Authority. The western basin now drains through Canal Oeste de Drenaje del Valle de Lajas into Bahía de Boquerón and the eastern basin drains through Canal Este de Drenaje del Valle de Lajas into Rio Loco, which empties into Bahía de Guánica. Laguna de Guánica and Ciénega El Anegado were drained.

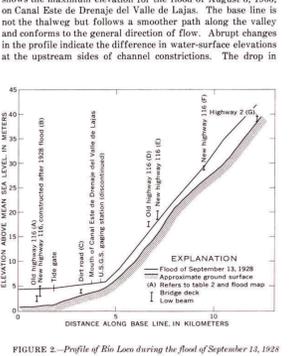
FIGURE 2.—Profile of Rio Loco during the flood of September 13, 1928.

**Flood profiles.**—Flood profiles were developed on the basis of elevations of floodmarks. The maximum water-surface elevations for the flood of September 13, 1928, on Quebrada Maney, Rio Loco, and Canal Este de Drenaje del Valle de Lajas, referred to the arbitrary base lines on the topographic map, are shown in figures 2 through 4. Figure 2 also shows the maximum elevation for the flood of August 3, 1963, on Canal Este de Drenaje del Valle de Lajas. The base line is not the thalweg but follows a smoother path along the valley and conforms to the general direction of flow. Abrupt changes in the profile indicate the difference in water-surface elevations at the upstream sides of channel constrictions. The drop in

Table 2.—Location and elevation of bridges in the flood area. (See flood map and figs. 2 and 4.)
